BP Texas City 2005 Refinery Explosion (Ref: U.S. Chemical Safety and Hazard Investigation Board)

Summary

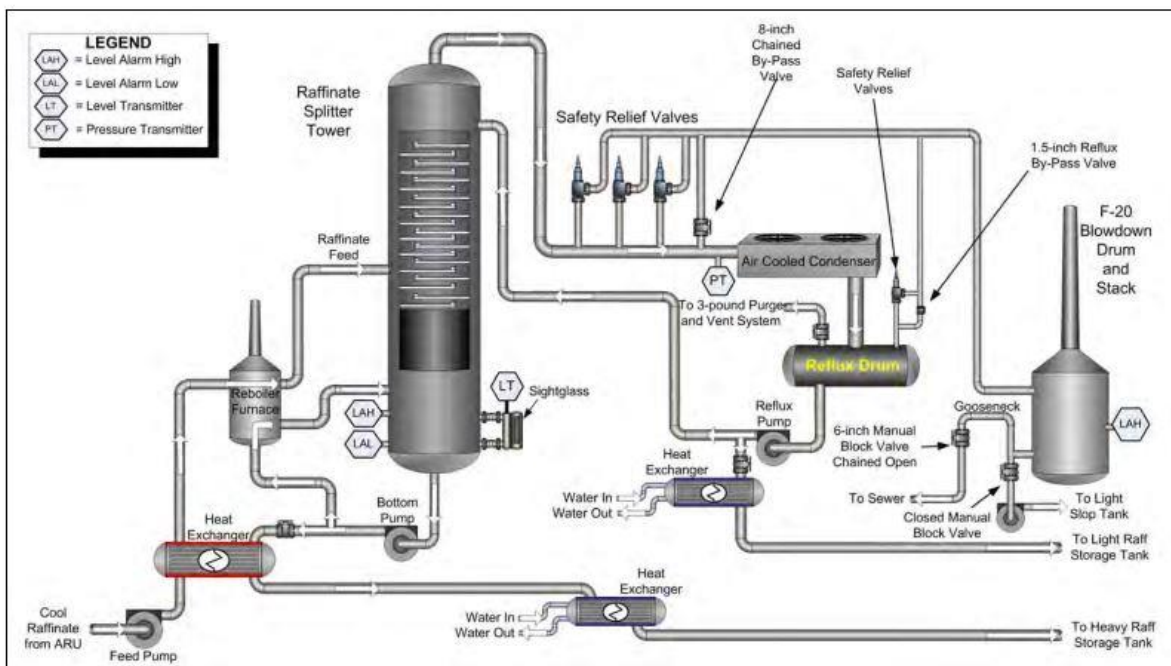
Figure 1. Raffinate section of the ISOM

The **raffinate splitter tower** (Fig.1) was a vertical distillation column with an inside diameter of 3.8 m and height of 52 m with an approximate liquid-full volume of 586,100 liters. The tower was fitted with 70 distillation trays that separated the light from the heavy raffinate. Liquid raffinate feed was pumped into the raffinate splitter tower near the tower's midpoint. An automatic flow control valve adjusted the feed rate. The feed was pre-heated by a heat exchanger using heavy raffinate product. Heavy raffinate was pumped from the bottom of the raffinate splitter tower and circulated through the reboiler furnace, where it was heated and then returned below the bottom tray. Heavy raffinate product was also taken off as a side stream at the discharge of the circulation pump and sent to storage. The flow of this side stream was controlled by a level control valve that, when placed in "automatic," adjusted to maintain a constant level in the tower. The splitter tower was equipped with a level transmitter, which provided a reading of liquid level in the tower to the control room board operator. The splitter tower had two separate alarms that indicated liquid level; one was programmed to sound when the transmitter reading reached 72 percent (a height of 2.3 meters in the tower). The second, a redundant hardwired high-level switch, was designed to sound when the liquid level reached 2.4 m in the tower (approximately 78 percent on the transmitter).

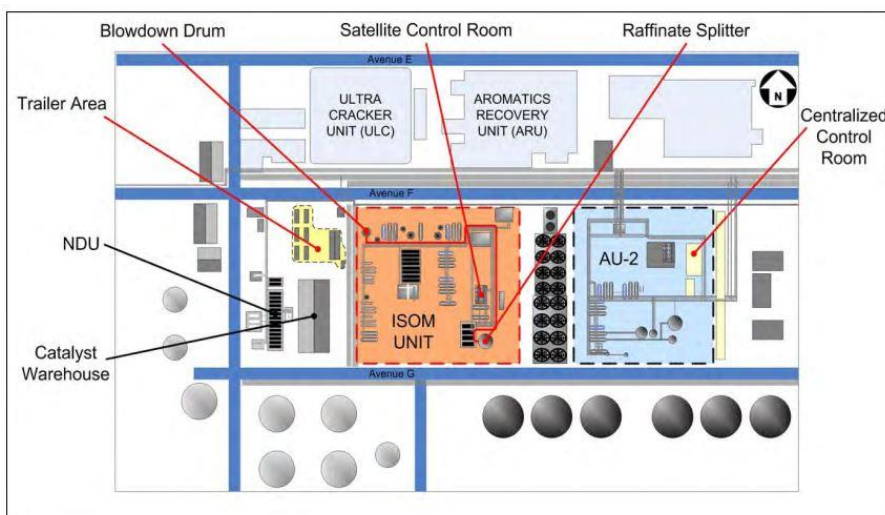
Figure 2. Layout of the refinery near the ISOM unit

On the morning of March 23, 2005, the raffinate splitter tower in the refinery’s ISOM unit (see Figure 2) was restarted after the turnaround¹. BP Pre-Startup Safety Review (PSSR) procedure should have been used to ensure that complete and thorough technical checks were carried out and that all non-essential personnel were clear during the start-up operation. Once completed, the PSSR would be signed off by refinery operations and safety managers, authorising the start-up work. However, the process safety coordinator responsible for an area of the refinery that includes the ISOM was unfamiliar with the applicability of the PSSR, and therefore, no PSSR procedure was conducted.
