MEC-E2004 Ship Dynamics

Manouvering – Case study of Crown Princess accident

Case study - Heeling Accident on M/V Crown Princess

- 18th of July, 2006 off Port Canaveral, Florida
- Based on NTSB report [Heeling Accident on M/V Crown Princess Atlantic Ocean Off Port Canaveral, Florida July 18, 2006 \(ntsb.gov\)](https://www.ntsb.gov/investigationreports/IR%2006001.pdf)
- 14 persons seriously injured and 284 persons with minor injuries due to excessive heeling of the vessel

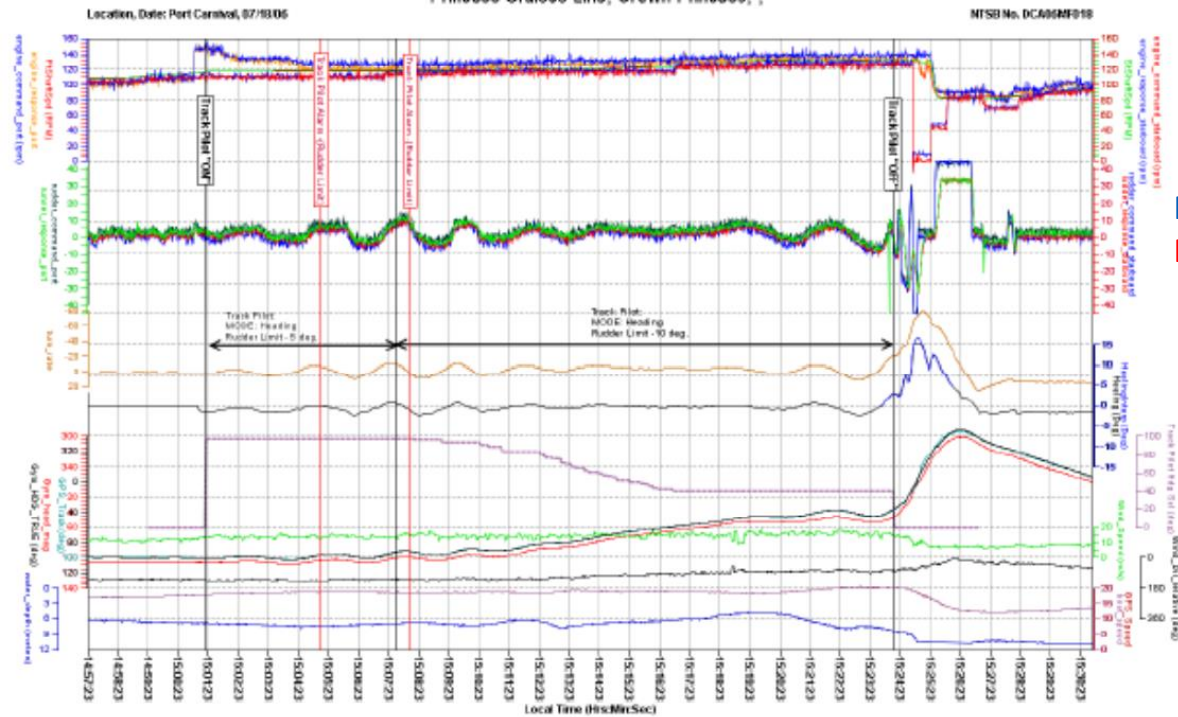
VDR Data

Rudder command
Rudder response

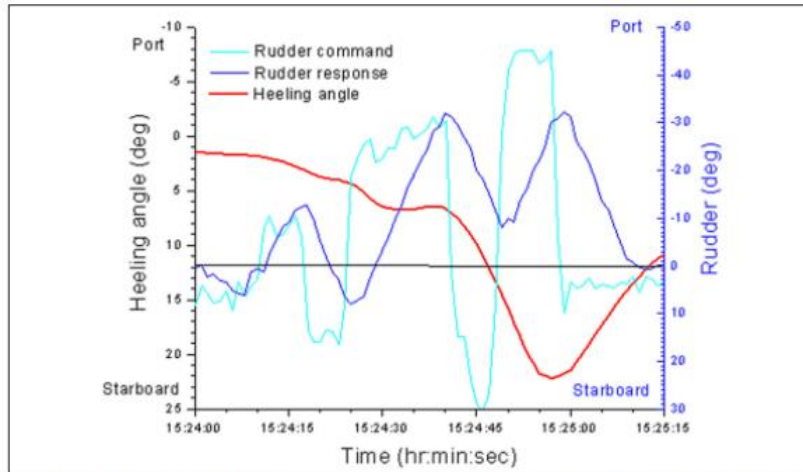
Figure 7. After the second officer began steering the vessel manually, he turned the wheel faster than the rudders could follow, as shown by the divergence between the rudder commands (light blue line) and the rudder responses (dark blue line). As the vessel attempted to respond to the commands, it heeled increasingly to starboard (red line).

1. Factors were not: Vessel mechanical condition, weather, sea state, and behavioral or physiological impairment of the crew
2. Officers didn't recognize high speed and shallow water impact on course stability
3. Inappropriate adjustment of trackpilot settings (ruddel limit instead of rudder economy)
4. Change of conn when vessel in non-static condition
5. Heeling caused by OOW disengaging trackilot and moving to manual steering and turning wheel manually (up to 45°)
6. No defiences in training
7. Errors in operating INS due to inadequate training
- ..

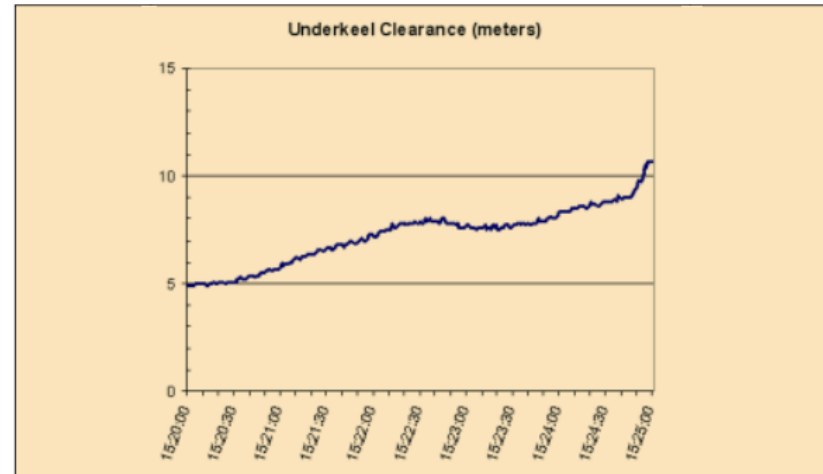
Figure 8. Underkeel clearance of the *Crown Princess* during the accident sequence, from data recorded by the vessel's VDR.
