The Space Shuttle *Challenger* Explosion in 1986

Main reference documents: Report on the Presidential Commission on the Space Shuttle Challenger Accident 1986, Feynman 1988, Vaughan 1996, Jensen 1996, Dunar & Waring 1999, Chiles 2002, Feldman 2004, Chernov & Sornette 2016, www.nasa.gov, Wikipedia.

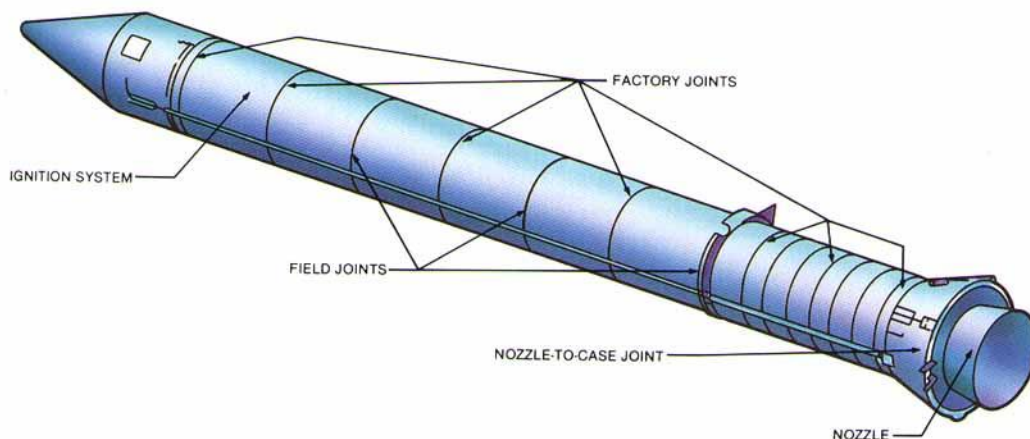
The gas leak was caused by failure in the O-rings of the booster (see Figure 3). The shuttle had several O-rings, made of a rubber compound, which were used to seal the Solid Rocket Booster field joints. The Solid Rocket Boosters are made in sections. There are two types of joints to hold the sections together: the permanent “factory joints” are sealed at the Morton Thiokol factory in Utah; the temporary “field joints” are sealed before each flight - at the Kennedy Space Center in Florida (Feynman, 1988). The O-rings measured 146 inches in diameter and were just 0.280 inch thick. Each one was moulded in one piece to span the entire circumference of the booster. Each solid rocket booster had three field joints, and the shuttle had two solid rocket boosters.

Figure 3. Solid Rocket Booster. NASA used to tell the press that the enormous power turned out by the booster matched the combined power of all the engines on seventeen 747 airliners at full thrust.

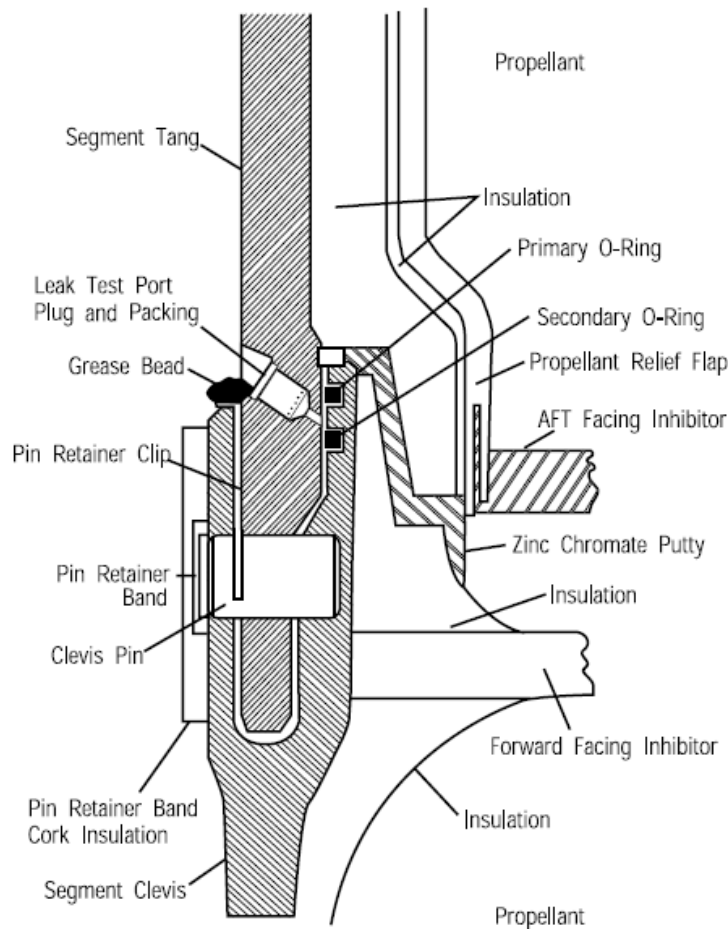
Post-accident investigations found that the resiliency of the O-rings was directly related to the temperature. The colder the ring, the slower it returns to its original shape after compression. Further, O-rings had caused problems for a longer period of time in the space shuttle program. The first erosion damage (0.053 inch, about one-fifth of the O-ring diameter) was detected in the field joint of the solid rocket boosters used on Columbia's second flight in 1981. However, no clear reason for the erosion could be determined. The worst possible erosion (0.090) was calculated at this point and tests were carried out to determine how much erosion the primary O-ring could tolerate. Tests put this value at 0.095. The *safety margin* was set at 0.090.

Figure 4. Cross section of SRM field joint (Dunar & Waring 1999, p. 342)

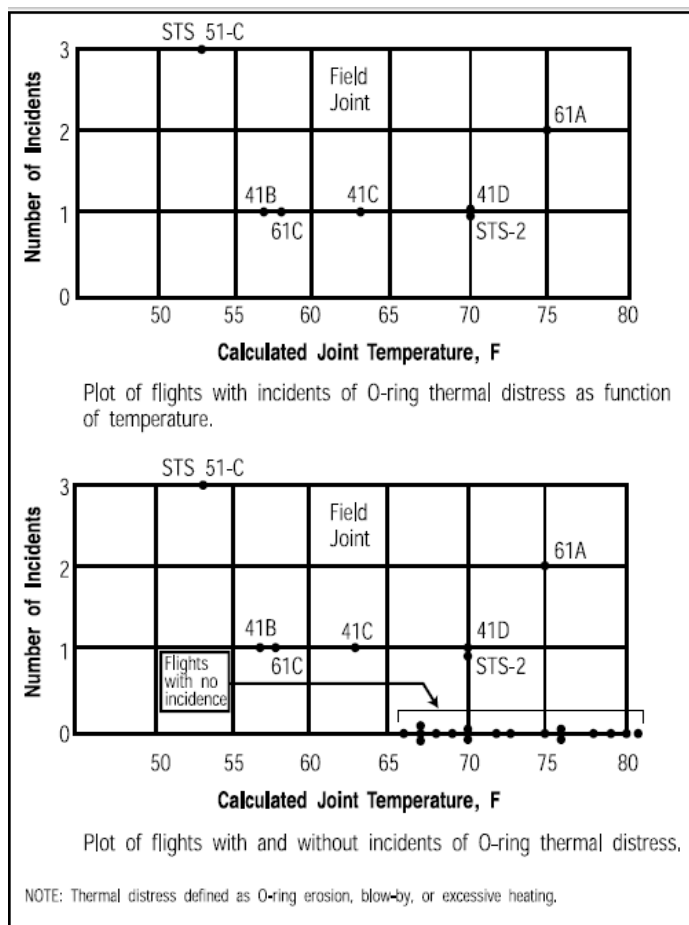
In the teleconference in which the fate of the Challenger was decided, the engineers at Morton Thiokol were trying to prove that temperature was a decisive factor affecting the O-ring damage. The problem was that their data was inconclusive. O-ring damage had happened at temperatures ranging all the way from 53° F to 75° F. Obviously, temperature could not be the only factor, if it was a factor at all, in contributing to O-ring damage. And what would be the effect of temperature in terms of numbers; how did it affect the O-rings, and which temperature level would suffice? For these questions there was no hard empirical evidence. The investigation board points out that if the engineers would have looked at all the flights, not only those with O-ring damage, a clearer picture would have emerged (see Figure 5). Only three instances of thermal damage to O-rings had been observed on the twenty flights made in temperatures of 66° F or more. All four flights staged at 63° F or below had shown O-ring damage. The engineers were more used to rapid corrective actions than trending and analysis.

Figure 5. Plot of flights with and without O-ring incidents shows that looking for linear correlation between temperature and the number of incidents was difficult when only the problematic flights were considered. However, if NASA or Thiokol would have looked at all flights, a pattern where the lack of incidents was explained by higher temperatures would have emerged. (figure from Dunar & Waring 1999, p. 359)
