**ARK-A3001 Design of Structures_Basics
Tension & Compression**

Toni Kotnik

Aalto University
Department of Architecture
Department of Civil Engineering

The Plan to Save Fallingwater

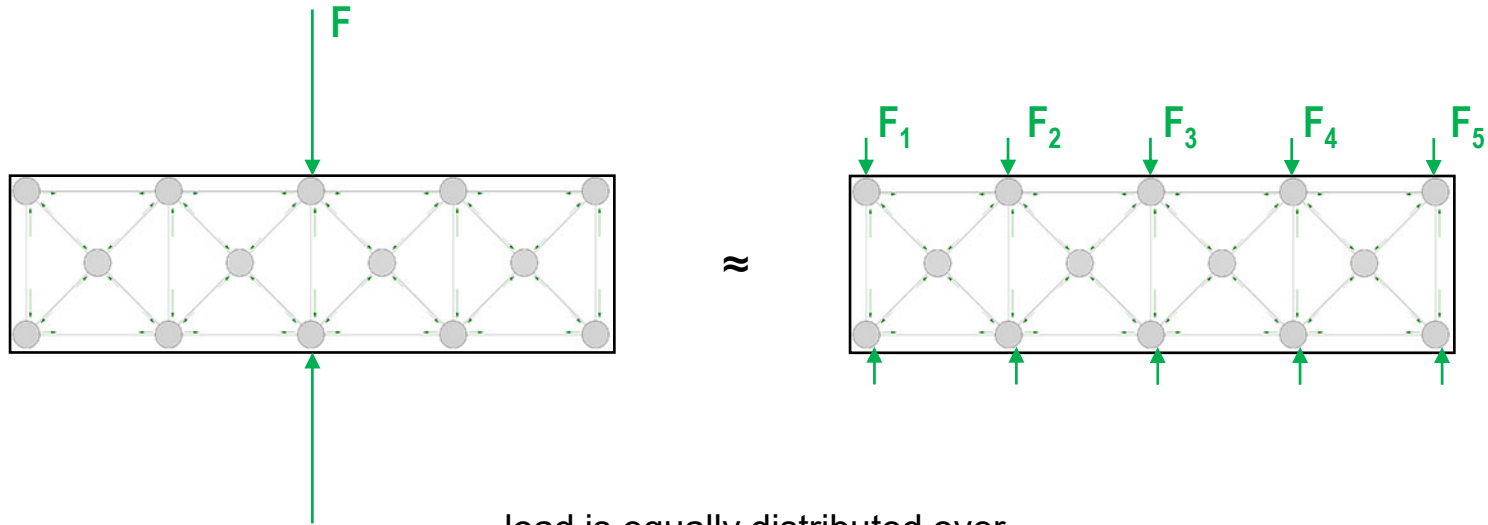
load is equally distributed over
the available cross sectional area
simplified model by Cauchy

$$\sigma = \frac{F}{A}$$

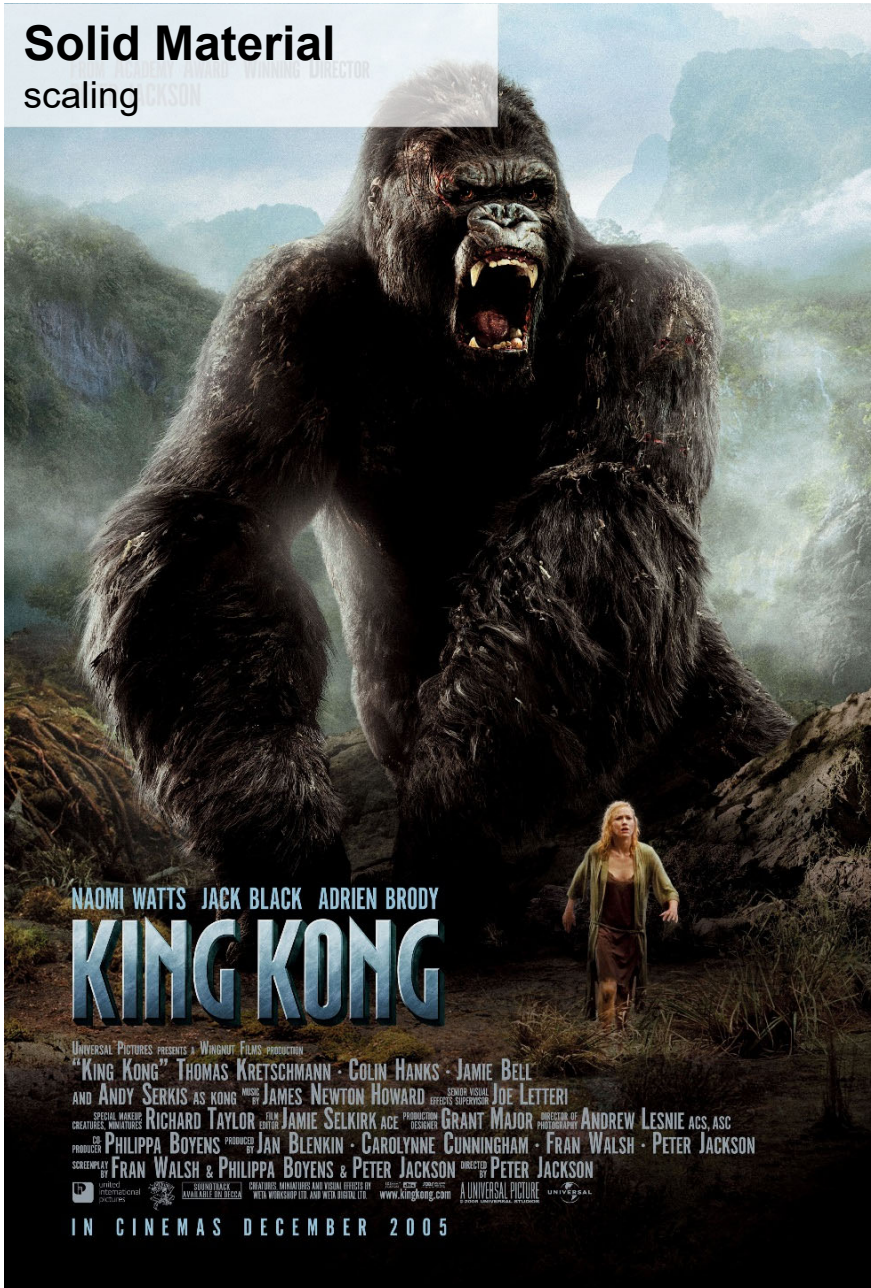
How does the stress in the bone changes if the size of the animal is scaled up by **factor 3**?

a model cannot simply be scaled up!

- change of dimensions or
- change of material or
- change of form

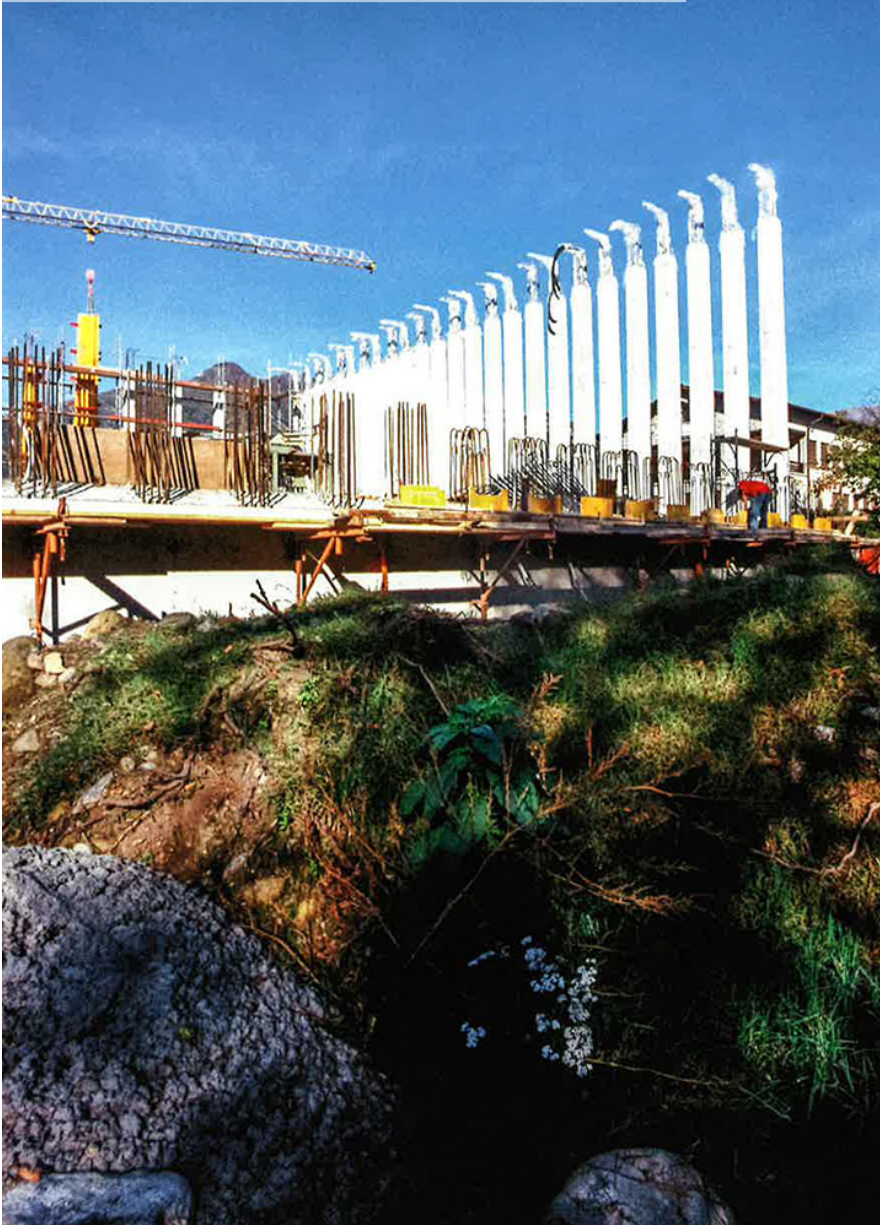
ACCIAIO D'ARMATURA : S 500
 CALCESTRUZZO : B 40/30
 DOSAGGIO : CP 325 kg/mc
 COPERTURA FERRI : 3,5 cm

LISTA FERRI 4639.BO.4.070
 N.B. Per il controllo dell'armatura l'ingegnere responsabile deve essere avvisato
 Livio Vacchini: Sportshall
 Losone, Switzerland, 1997

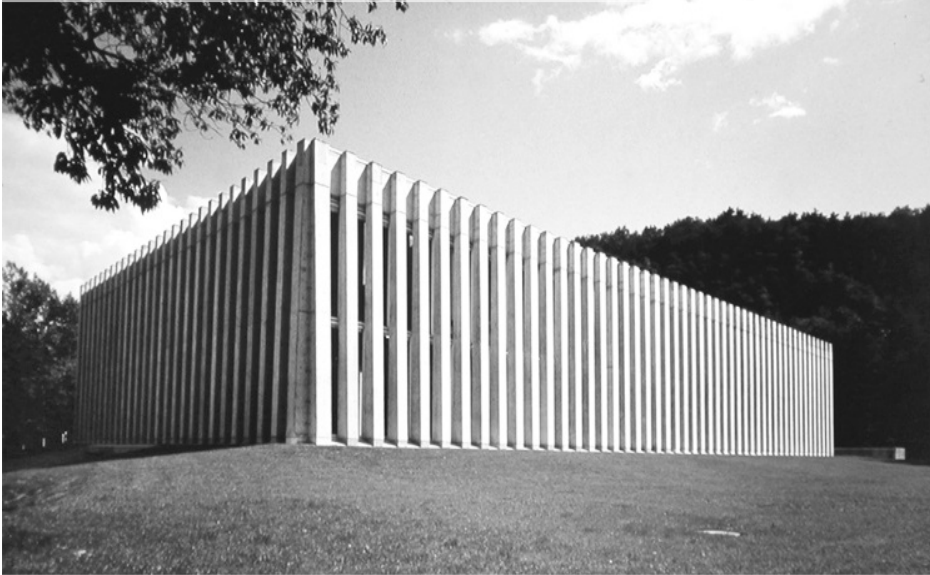
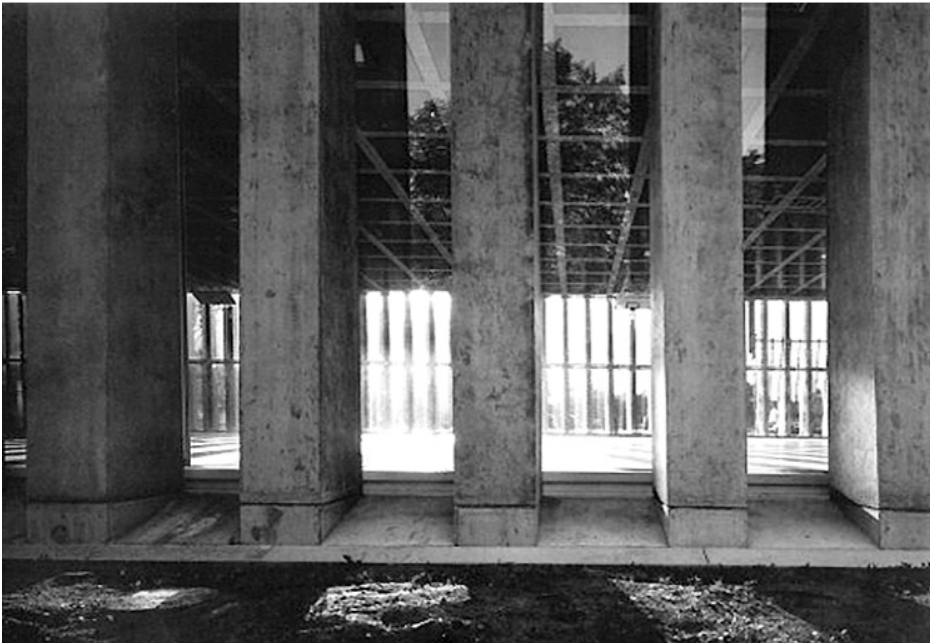
Post-Tensioned Beam

Livio Vacchini: Sportshall
Losone, Switzerland, 1997

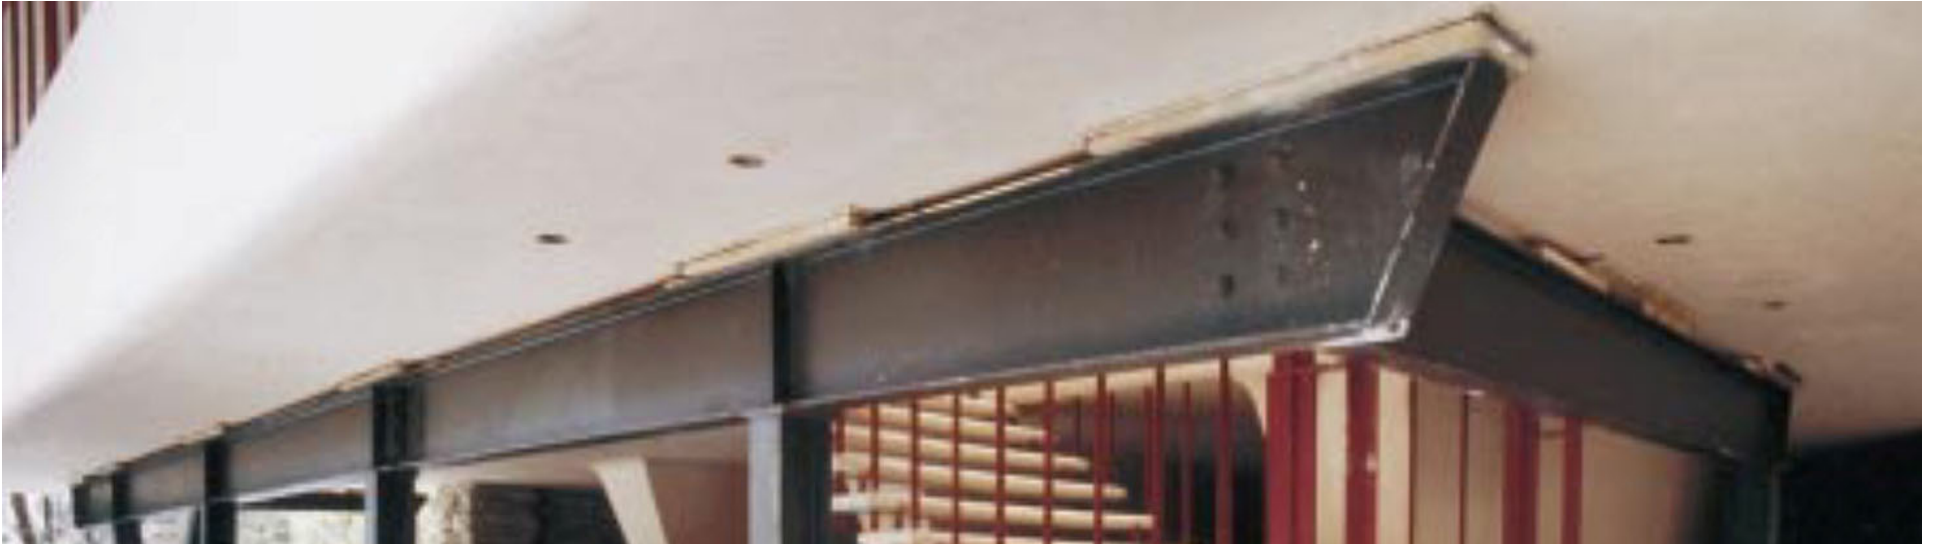
large deformation of terraces
up to 30 cm

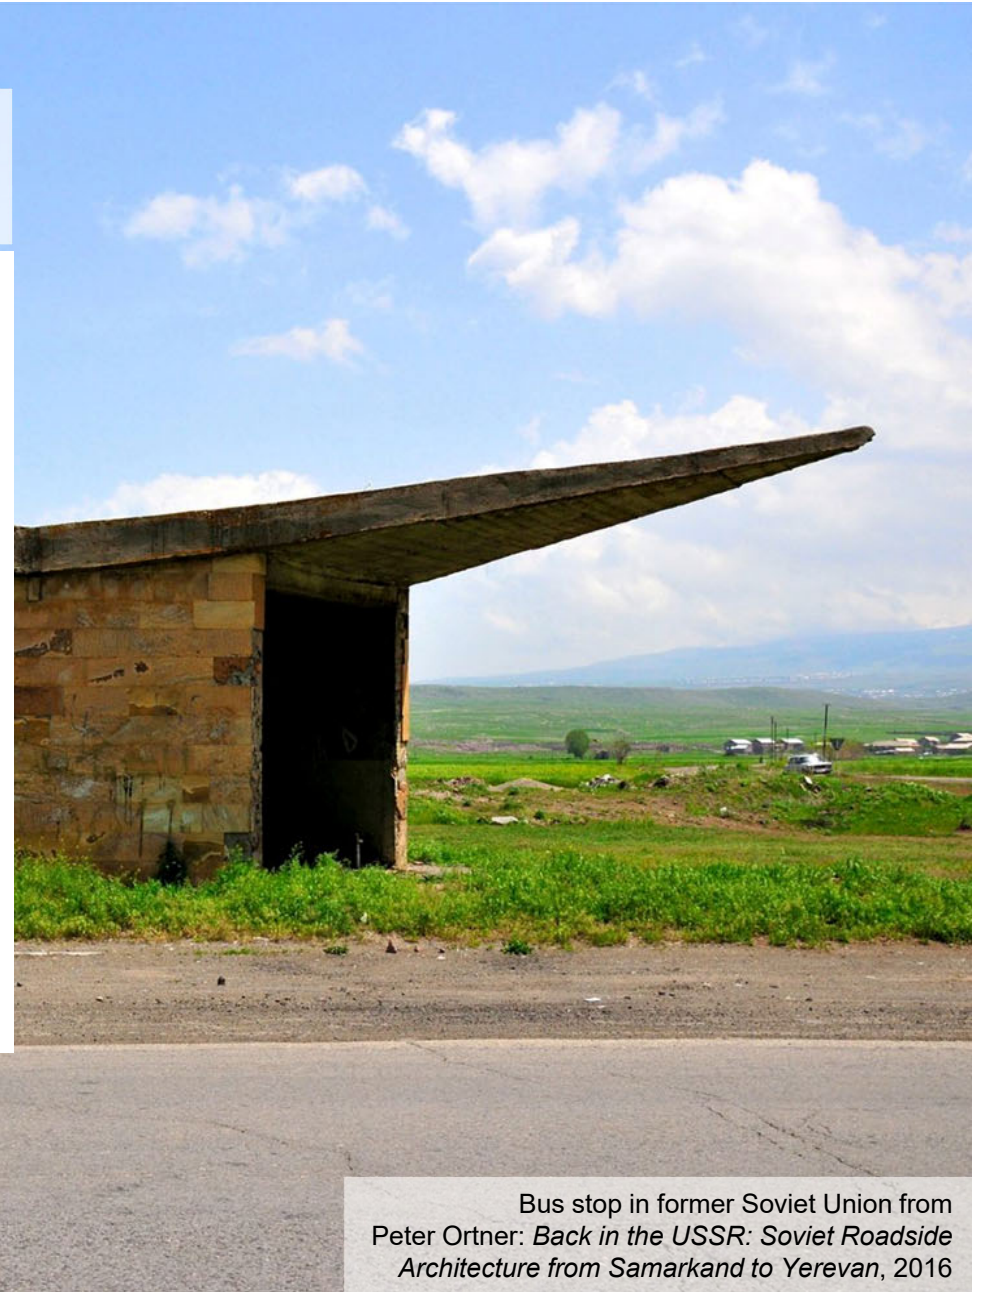
Exercise 4.1

Given is the location plan for a bus stop together with the inner forces. Construct the force plan and sketch the deformation of the bus stop under the load.

Bus stop in former Soviet Union from Peter Ortner: *Back in the USSR: Soviet Roadside Architecture from Samarkand to Yerevan*, 2016

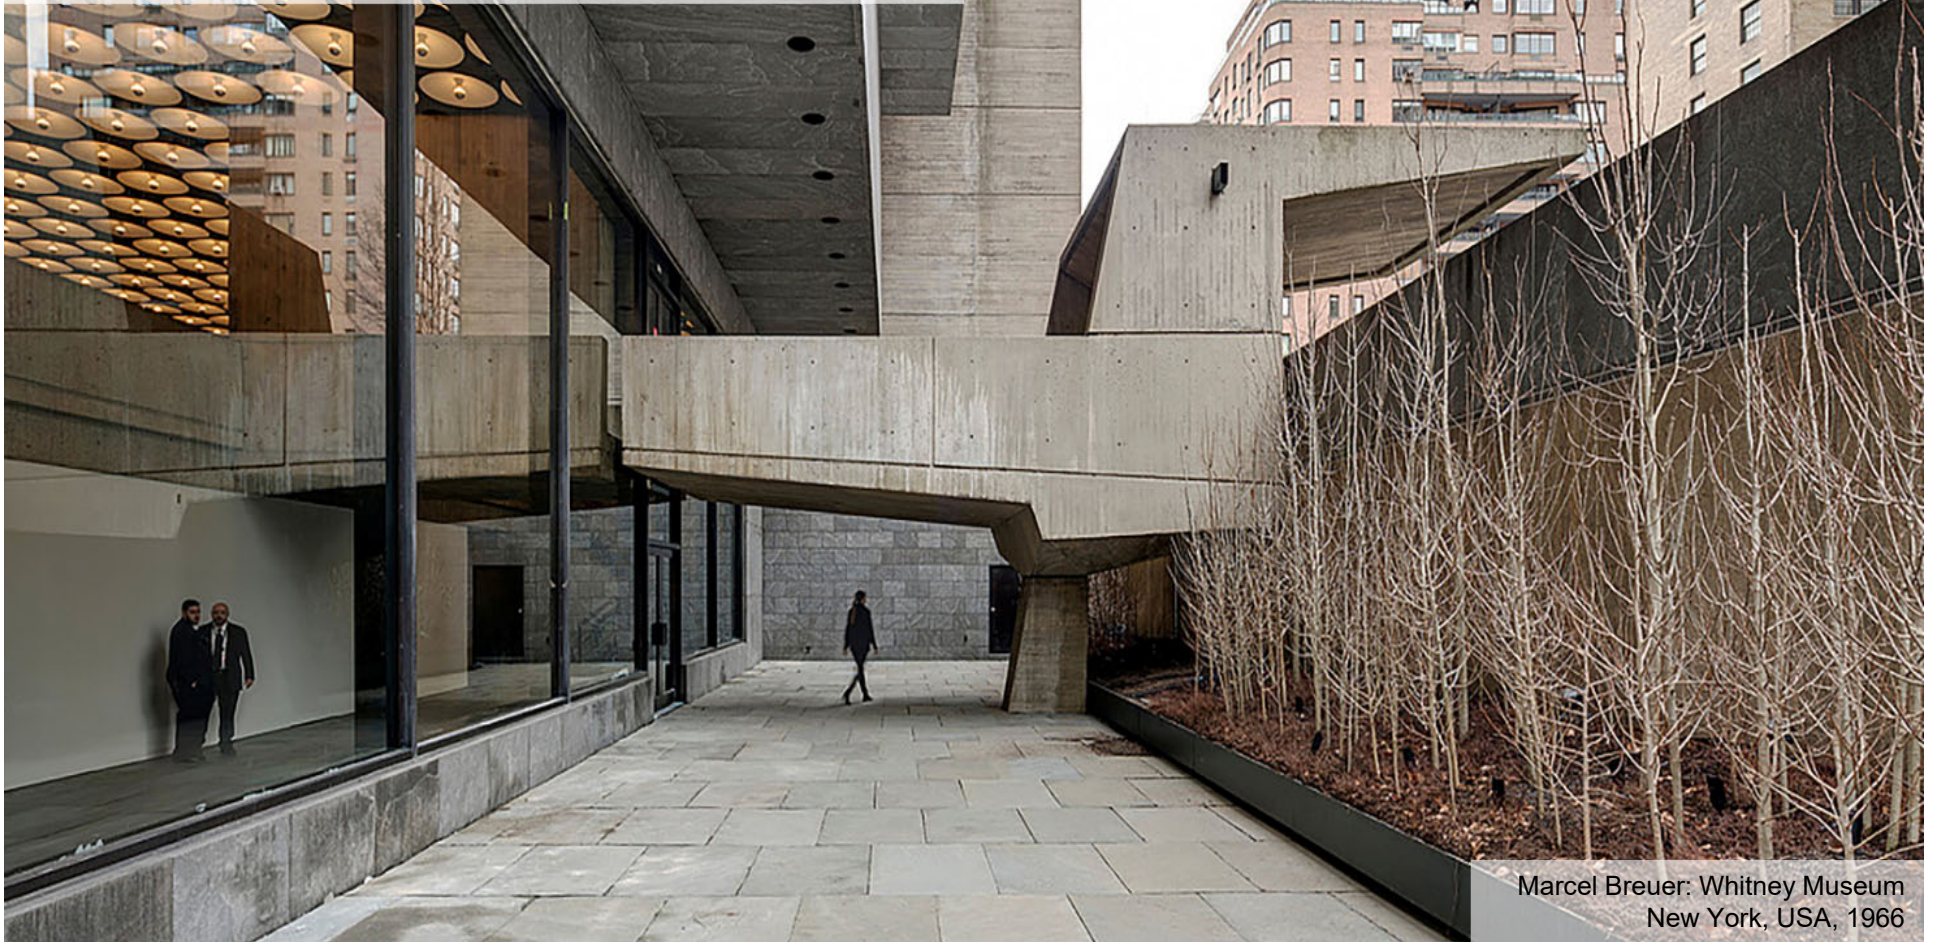
Exercise 4.3

The entrance to the Whitney Museum in New York designed by Marcel Breuer is defined by a sculptural bridge out of reinforced concrete. Sketch the load, the inner force flow and the support forces into the image and give a short argument for the correctness of your proposal (hint: exercise 4.1 & 4.2).

Marcel Breuer: Whitney Museum
New York, USA, 1966

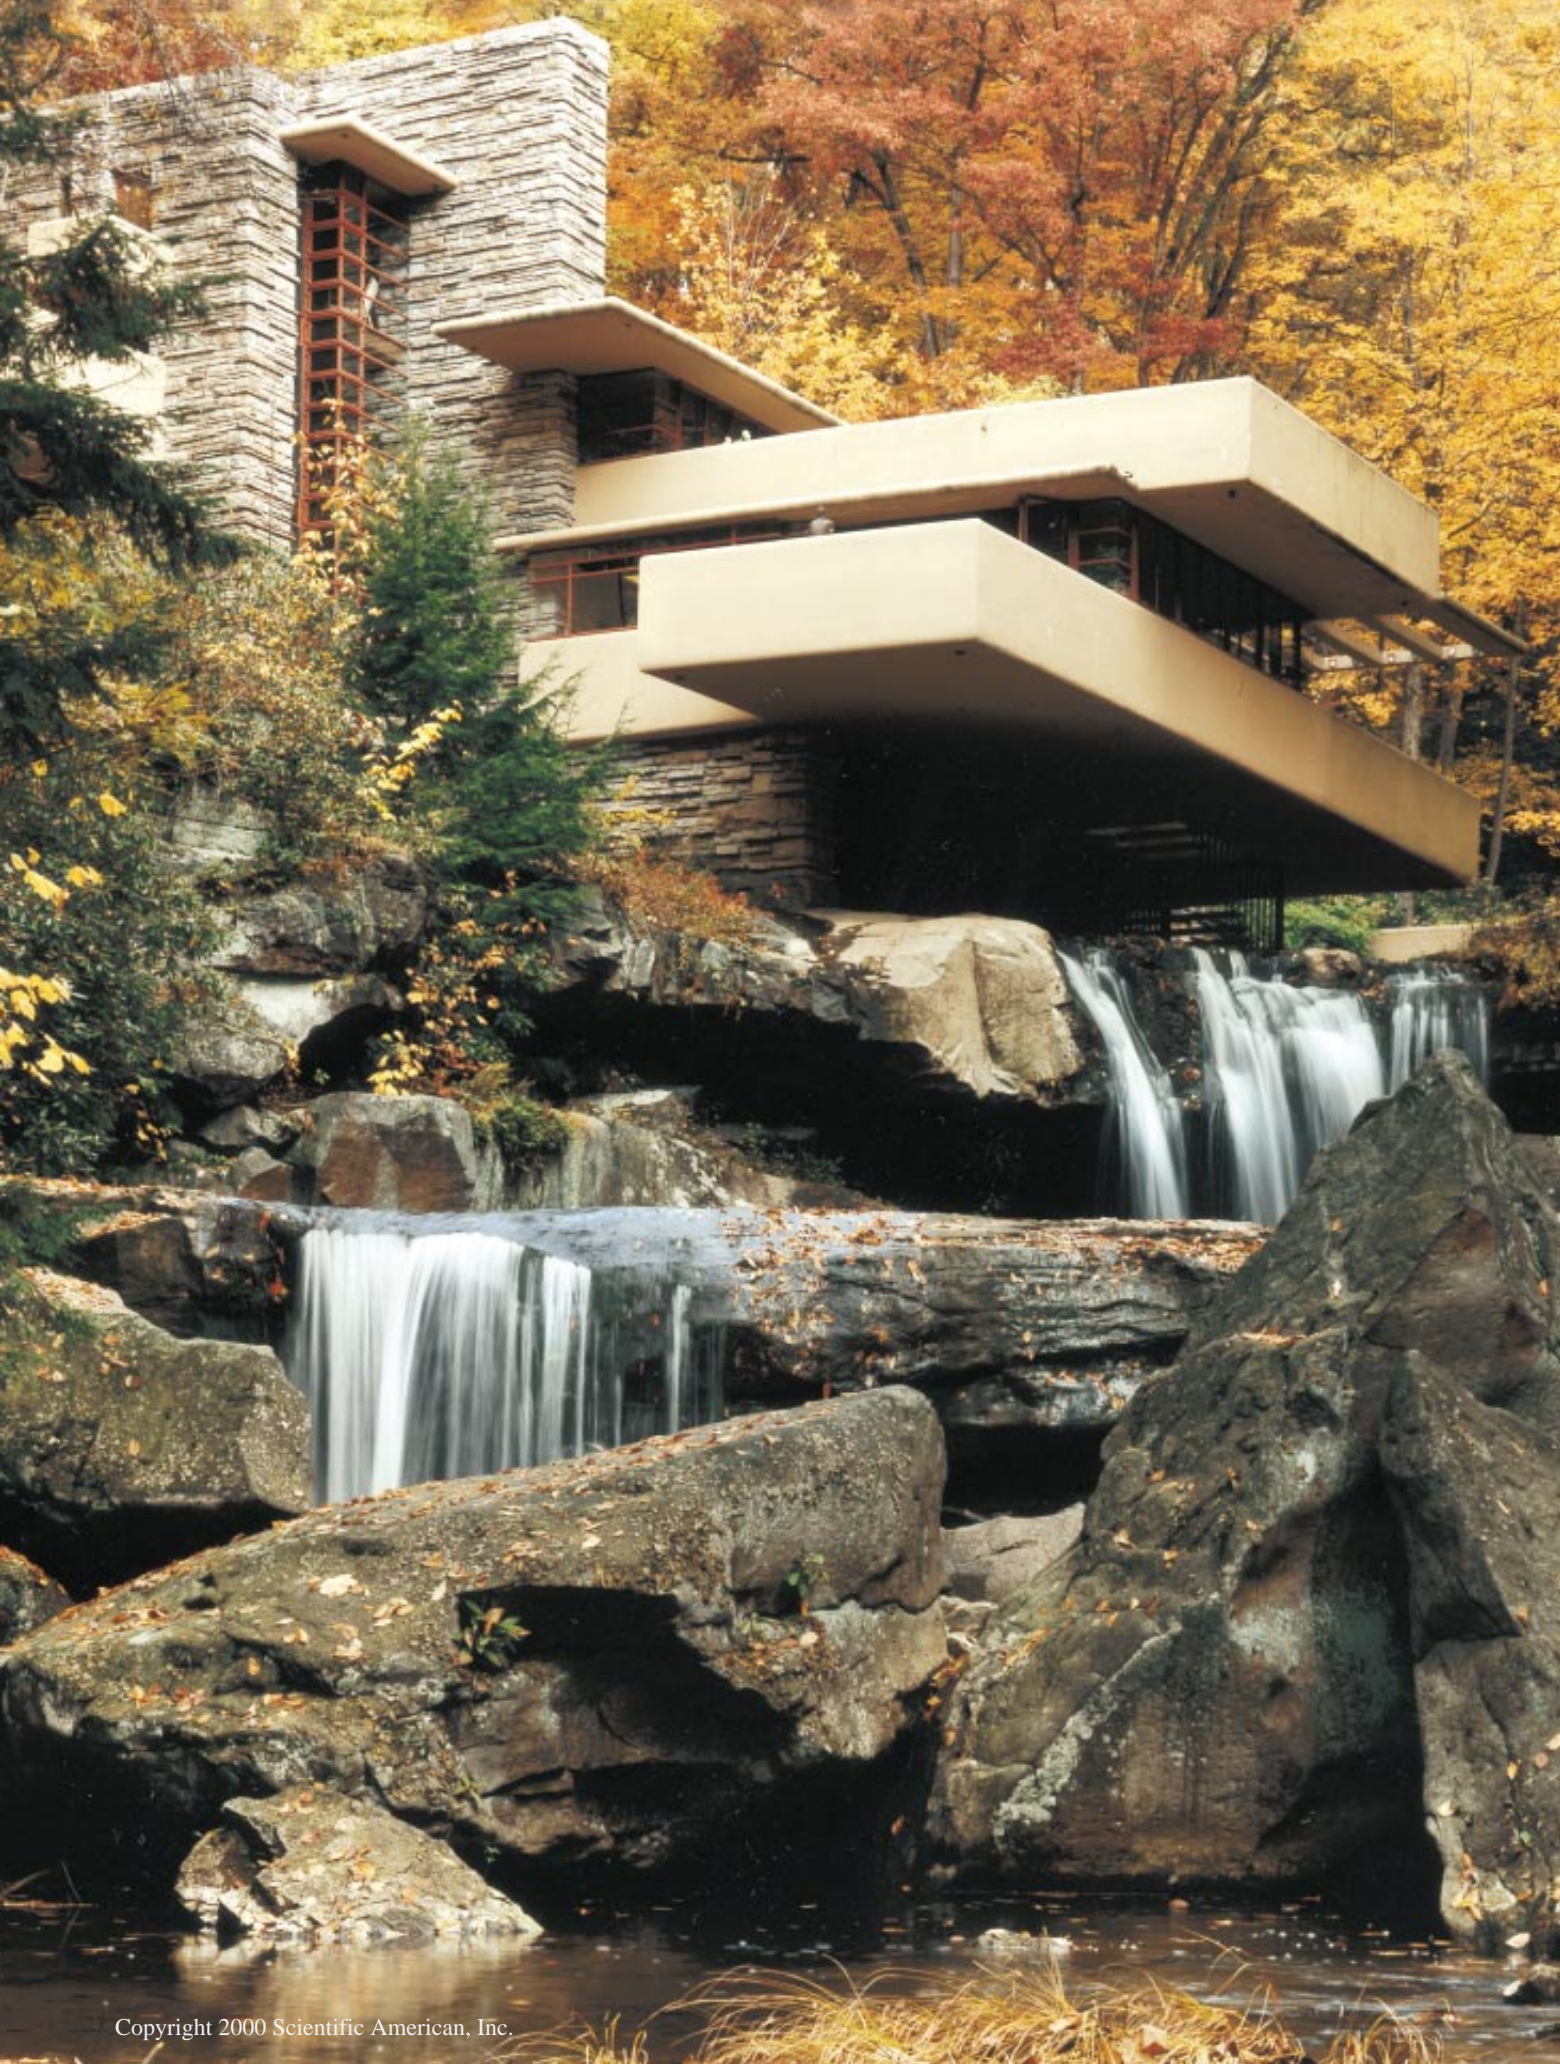
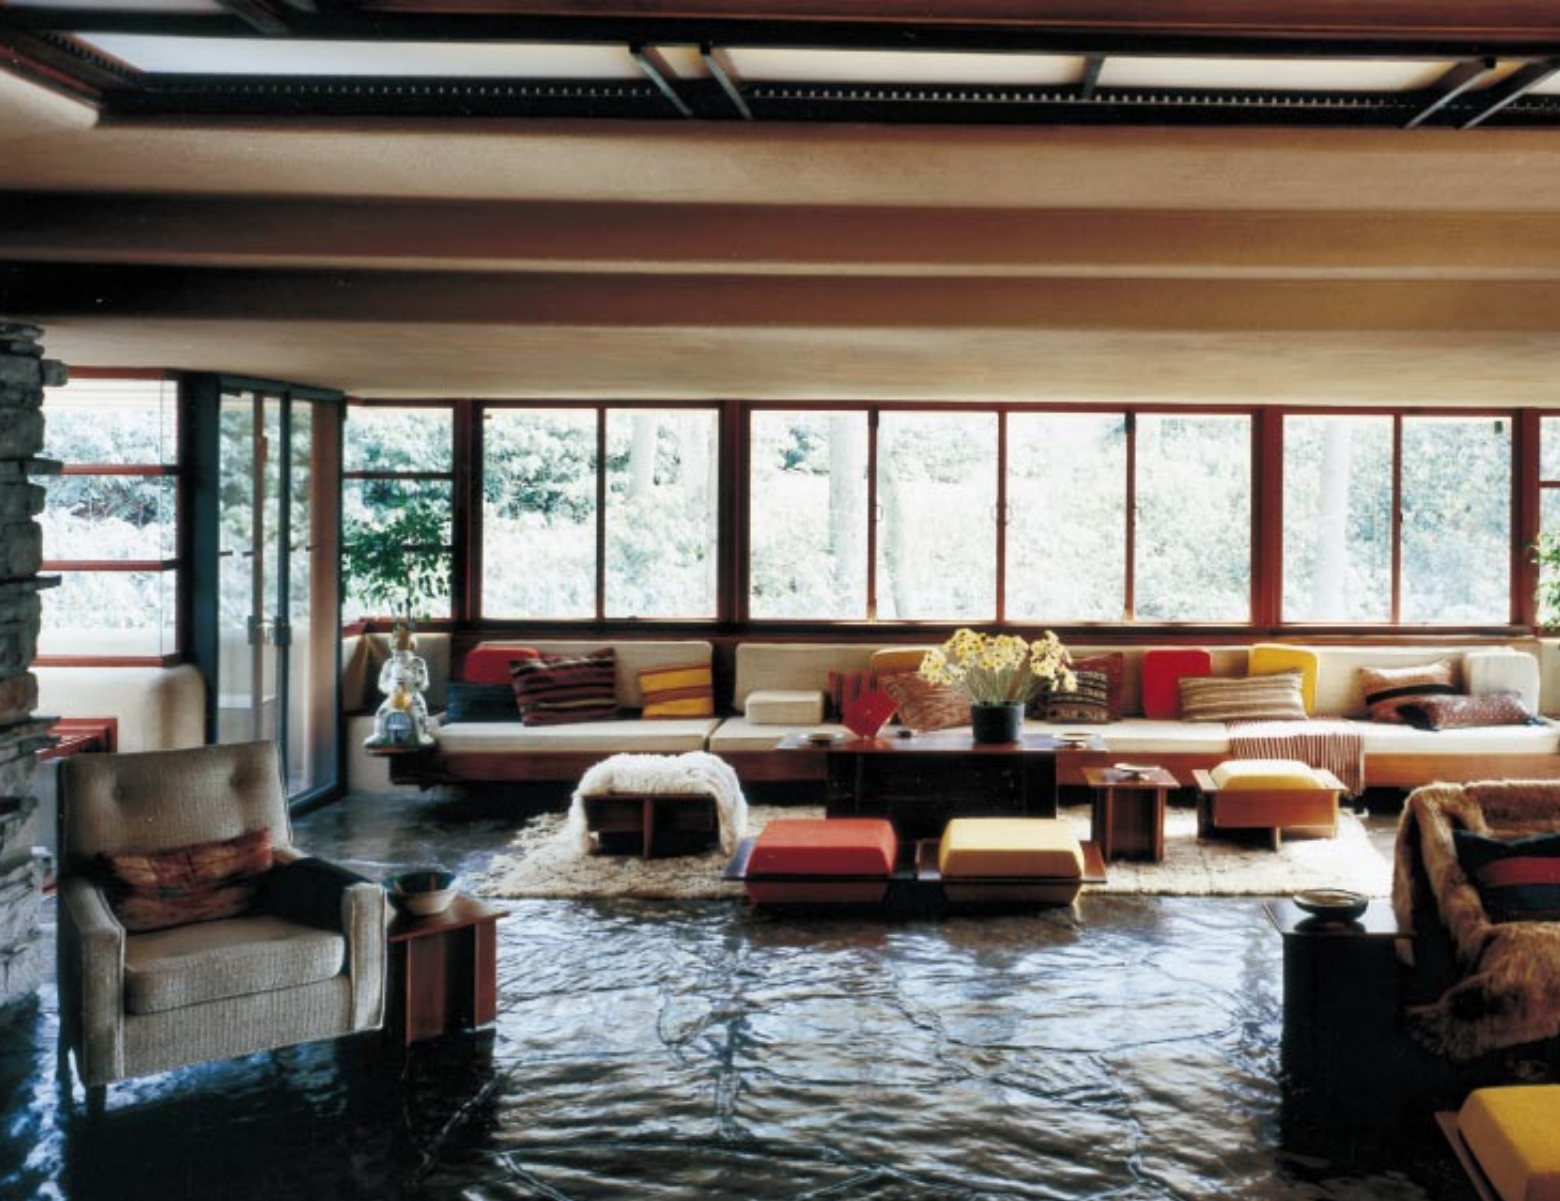
*This breathtaking house designed by
Frank Lloyd Wright was in danger of
collapse until an engineering firm found
a way to stop it from falling down*

Yet this incomparable structure has a critical flaw. Wright's design did not provide enough support for the portion of the house that hangs over the stream. As a result, Fallingwater's famed terraces began to droop as soon as they were built, causing large cracks to appear in the concrete. What is more, the sagging gradually increased over the next six decades. In 1995 the Western Pennsylvania Conservancy, which owns Fallingwater, was concerned enough to hire our engineering firm, Robert Silman Associates in New York City, to examine the house's structural problems. The results of our investigation indicated that the beams supporting the house were continuing to bend and that the building would eventually collapse into the stream below if nothing was done.

In 1996 the conservancy prudently decided to shore up Fallingwater with temporary steel beams and columns. At the same time, our office began to draw up a plan to permanently repair the house. We had previously worked on two other buildings designed by Wright—the Darwin D. Martin House in Buffalo, N.Y., and Wingspread in Racine, Wis.—but Fallingwater posed a unique challenge. To determine how to relieve the stresses that were threatening the house, our engineers probed the building with radar and ultrasonic pulses, then performed a rigorous structural analysis. Along the way we also tried to retrace the thinking of Wright and his apprentices. We now have a plausible theory to explain how the design of Fallingwater went awry.

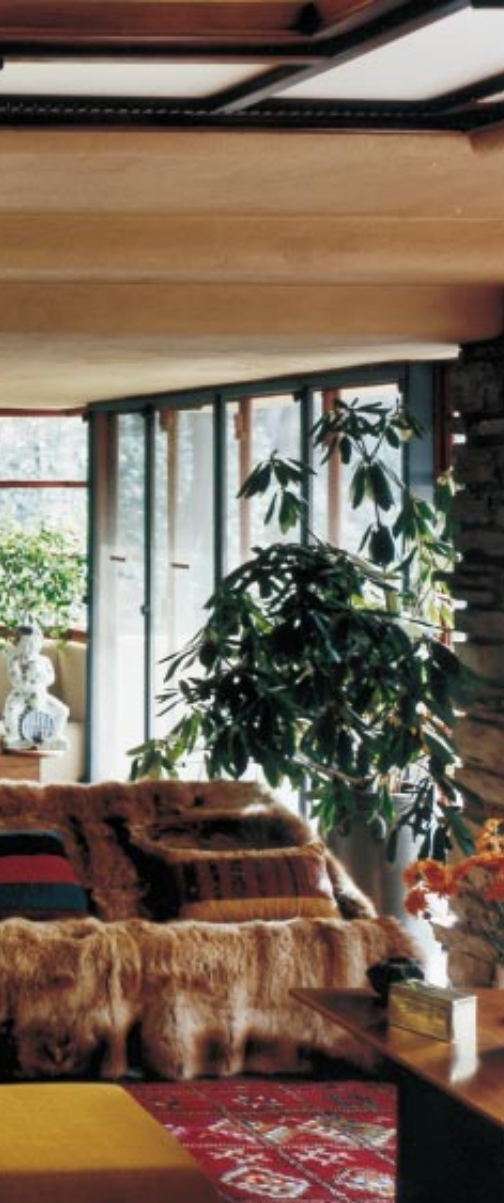
INTERIOR VIEW of Fallingwater's living room shows the stone floor that rests on the house's cantilever beams. The windows at the south end of the room are divided by four steel mullions that help support the weight of the second floor.

out than the first floor does, extending an additional 1.83 meters (six feet) southward [see left illustration below]. Four T-shaped window mullions rise from the south edge of the living room to the terrace above. At first glance these steel mullions appear to be merely decorative, but we would eventually learn that they, too, play a key role in Fallingwater's structure.

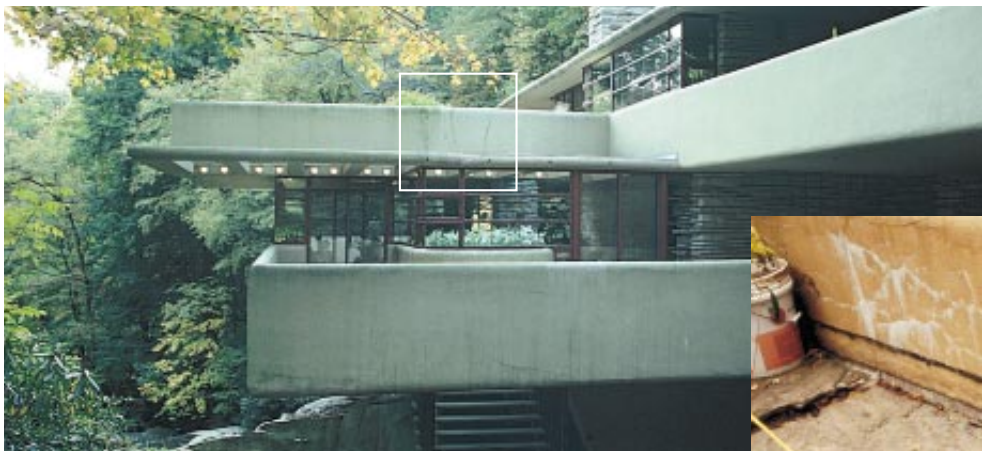
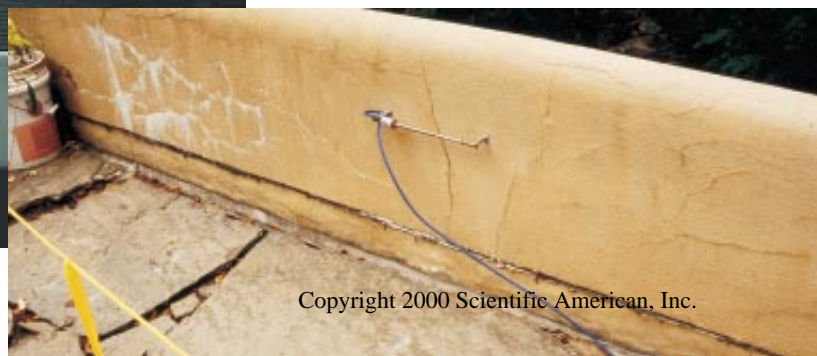
CRACKS IN THE PARAPETS of the second-floor terrace appeared as a result of the stresses in the concrete structure (left). Electronic monitors attached to the parapets measured changes in the width of the cracks over 18 months and confirmed that they were growing (below).

The problem became even more apparent after the completion of the second floor. Soon after workers removed the formwork from the concrete of the master bedroom terrace, two cracks appeared in the terrace's parapets. In 1937 Metzger-Richardson conducted load tests of the structure and calculated that the stresses in the cantilever beams were near or even exceeded the margins of safety. The engineering firm recommended placing permanent props in the streambed to support the first floor and thus reduce the length of the cantilevers. But Wright stubbornly defend-

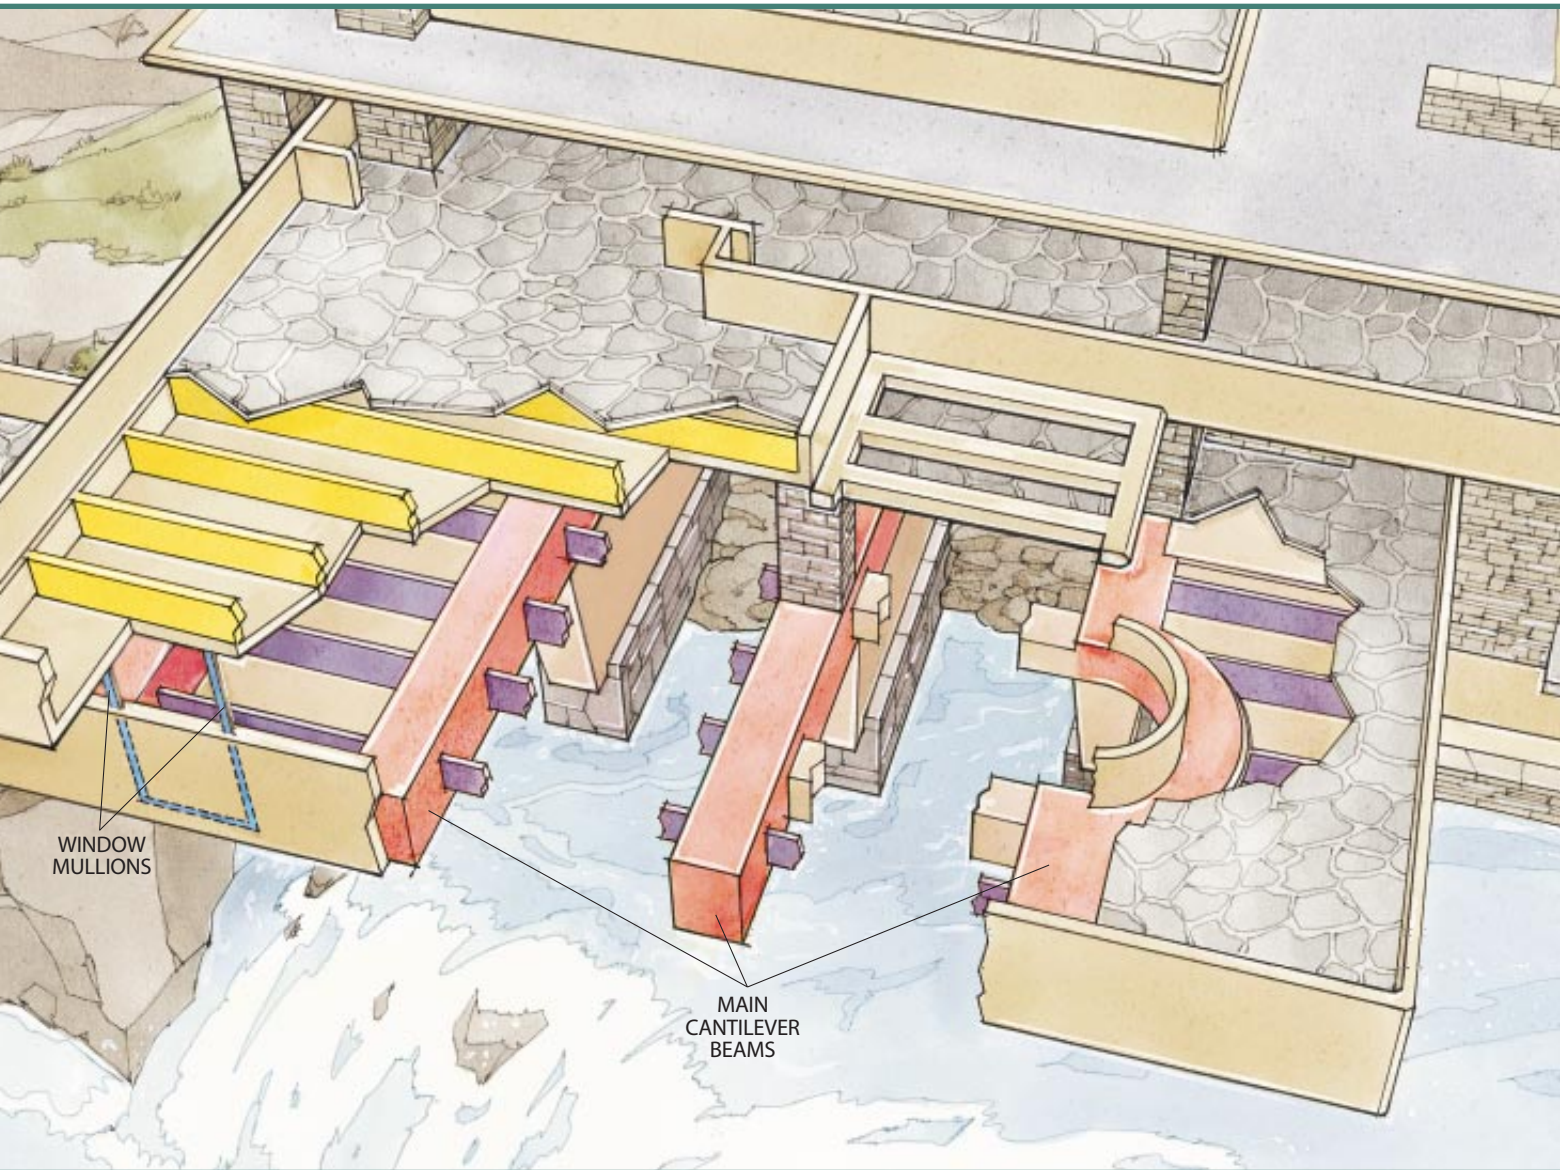
FRANK LLOYD WRIGHT'S DESIGN for Fallingwater combined beams and parapets made of reinforced concrete with floors and walls made of sandstone (opposite page). A cutaway of the portion of the house overhanging Bear Run (below) shows the concrete bolsters that rise

from the ground and support the horizontal cantilever beams (red). The beams are connected to one another by concrete joists (purple). The steel window mullions (blue) embedded in the first-floor parapet help support the concrete joists (yellow) of the second-floor terrace.

the house so that the section over Bear Run acts as a cantilever. Like a diving board, it has a fixed end and a free end. The fixed end consists of four large bolsters, three of reinforced concrete (that is, concrete with steel bars embedded in it) and one of stone masonry. These bolsters rise from the sandstone ledge to the building's first floor [see *illustration on pages 92 and 93*]. Each one supports a horizontal reinforced-concrete beam that extends some 4.42 meters (14.5 feet) beyond the bolster, jutting southward over the stream. The beams are connected to one another by concrete joists, each 100 millimeters (four inches) wide. Together the beams and joists create a rectilinear grid. Above this grid are wooden two-by-fours and planking, which support the stone floor of the house's living room and the first-floor terraces.

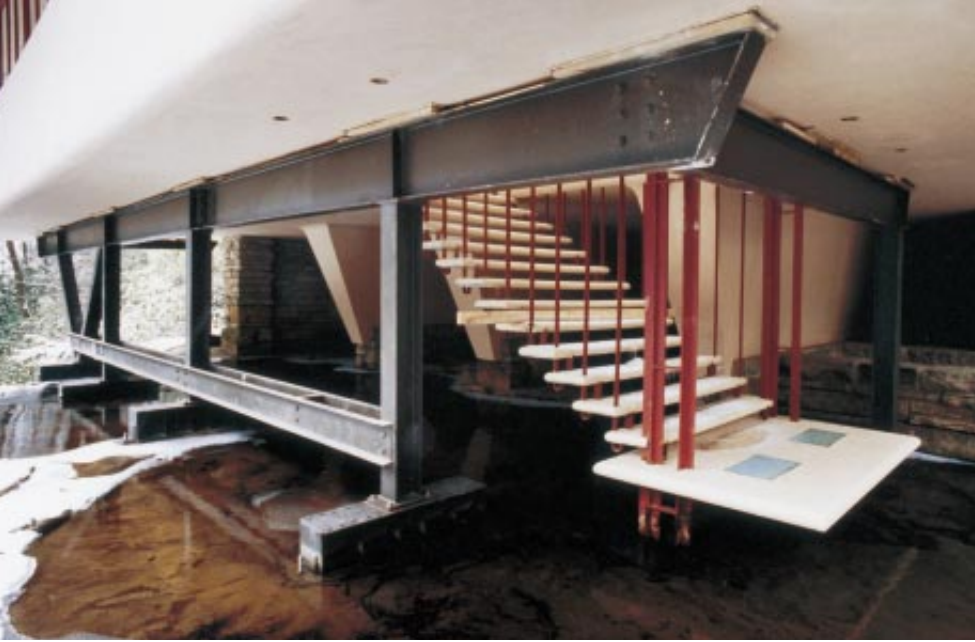
TEMPORARY SHORING installed in 1997 ensures that Fallingwater will not collapse before permanent repairs can be made to the structure. A line of steel columns and girders rising from the streambed of Bear Run supports the concrete underside of the house's cantilevered first floor.

Thus, in 1997 workers installed a relatively unobtrusive line of steel columns and girders rising from the streambed of Bear Run to the underside of the first floor [see illustration at left]. In addition, they also shored a portion of the streambed itself, the jutting sandstone ledge over which Bear Run cascades. The ledge was braced with pipe struts in a cave behind the waterfall. The temporary shoring, which ensures the safety of the tourists who continue to visit the house, will remain in place until the permanent repairs are completed.

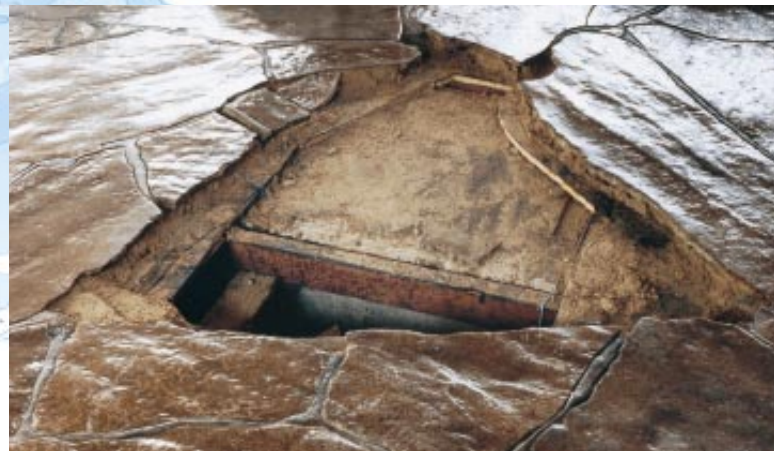
PLANNED REPAIRS involve relieving the stresses in the cantilever beams through the creative use of post-tensioning. Steel cables will be rigged on both sides of each beam, anchored in concrete blocks attached to the beam's ends (left). The cables will then be tightened from the outside using a hydraulic jack. The tension in the cables will exert a positive bending moment on the beam, counteracting the negative moment caused by cantilever action. A section of one cantilever beam beneath the living room floor (below) has already been exposed to allow engineers to inspect it.

The repair scheme calls for the stone floor of the living room to be removed temporarily. This will allow access to the three main cantilever beams from above. At the south end of each beam—the end jutting over Bear Run—we will attach concrete blocks to both sides of the beam [see left illustration on opposite page]. Into each block we will insert a hollow duct with an inside diameter of 6.35 millimeters. The ducts will run alongside the beams, angling upward and extending through holes drilled in the concrete joists. We will also drill holes in the exterior of the south parapet so that high-strength post-tensioning cable can be threaded through the ducts.

The cables will be anchored at the north end of each beam. At the south end, we will tighten the cables from the outside using a hydraulic jack. The tightened cables will be rigged in such a way that they exert a positive bending moment on each cantilever beam. This positive moment will essentially coun-

teract the negative moment caused by cantilever action, lowering the tension in the upper part of the beam and the compression in the lower part. We will also connect post-tensioning cables to the parapet edge beams in the east and west terraces to relieve the stresses in those beams. On the second floor, we plan to reinforce the overstressed concrete joist just above the steel window mullions, either by bolting steel channels to each side of the joist or by bonding carbon-fiber plates to it. At the conclusion of the project, we will patch and paint the holes in the parapet, replace the stone floor and remove the temporary shoring.
