## Erosion wear of CrN, TiN, CrAlN, and TiAlN PVD nitride coatings

Deng Jianxin<sup>\*</sup>, Wu Fengfang, Lian Yunsong, Xing Youqiang, Li Shipeng

Department of Mechanical Engineering, Shandong University, Jinan 250061, Shandong Province, PR China

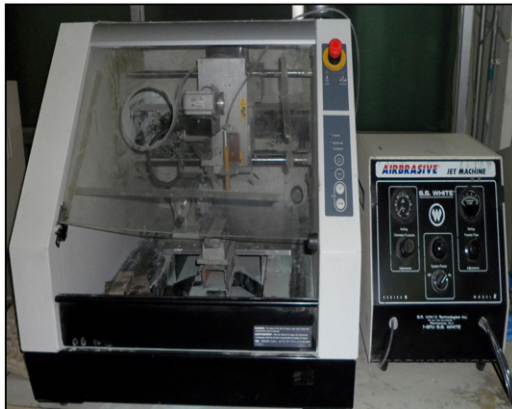
**Fig. 1.** Photo of the erosion test equipment.

Erosion wear tests were conducted with a dry blasting machine tool. The photo of this equipment is shown in Fig. 1. The impingement

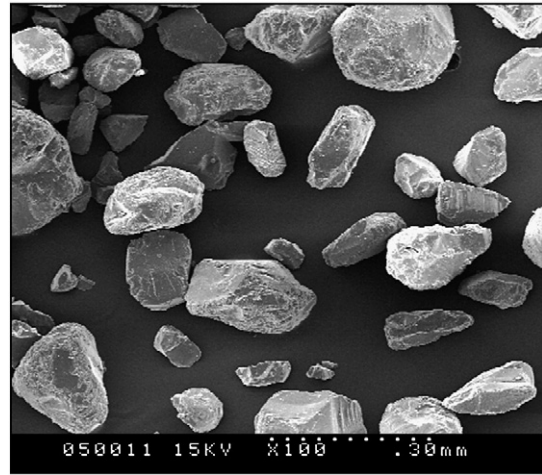
**Fig. 2.** SEM micrograph of the SiC abrasives used for erosion tests.

angle of the jet relative to the coating surface was 90°. The test piece was mounted at 20 mm distance from the end of the nozzle. The compressed air pressure was set at 0.5 MPa. The erodent abrasives used in this study were of silicon carbide (SiC) powders with 40–100 μm grain size. The SEM micrograph of the SiC powders is shown in Fig. 2. As these abrasives are more durable and create less dust than sand, and typically are reclaimed and reused. The wear mass loss of the coatings after the tests was too small to be resolved by weighing. Instead, the geometry of the eroded surface was measured with an optical profilometer (Wyko NT9300). At each test interval the distance between the original and the worn surfaces at the deepest position was measured and designated as the wear depth. The erosion rates (*W*) of the coatings are defined as the wear depth of the coating divided by the erosion time. Since the test parameters were kept constant, wear of the coatings should only depend on the nature of the coatings. The eroded surfaces of the nitride coatings were examined by scanning electron microscopy.

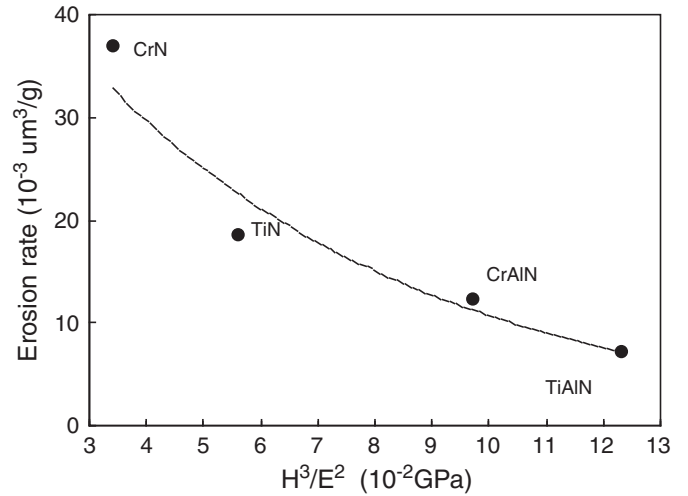
Fig. 13. Interdependence of  $H^3/E^2$  and erosion rate of CrN, TiN, CrAlN, and TiAlN coatings.

In the erosion wear tests, fine particles are accelerated and are directed towards coating surfaces. As the particles impact the coating surface, they cause a small fracture, and the coating is removed primarily by repeated impact of the abrasive particles. Several studies [25–29] have been shown that impact of brittle materials by hard particles is generally thought to result from elastic/plastic fracture. This type of fracture is characterized firstly by plastic deformation of the contact area between the impacting particle and the material surface, with subsurface lateral cracks propagating outward from the base of the contact zone on the planes nearly parallel to the surface, and with median cracks propagating from the contact zone normal to the surface. The interaction of lateral and radial cracks is considered to result in material removal. Analysis of erosion of brittle materials typically recognizes two models of material removal: a ductile plowing type of material removal, and a fracture induced removal process. In the class of hard coatings presently being considered, both processes may occur, depending on the specific stress state. The high hardness of the coating is only one parameter which ensures scratch and abrasion resistance. The coatings must be highly resistant also to plastic deformation during contact events. The resistance of coating to plastic deformation can be controlled by the film hardness  $H$  and its elastic modulus  $E$ . The ratio  $H^3/E^2$  is a parameter which controls the resistance of materials to plastic deformation [30,31]. Fig. 13 shows the interdependence of  $H^3/E^2$  and erosion rate of the coatings. It is indicated that the  $H^3/E^2$  of the coating material had an important influence on its erosion rate. The TiAlN coating is characterized by high resistance to plastic deformation ( $H^3/E^2$ ) and lower erosion rate, while the coatings with relative low  $H^3/E^2$  showed higher erosion rate.
